# Disasters Induced by Sediment Yields — Historical Review —

Syunsuke Ikeda

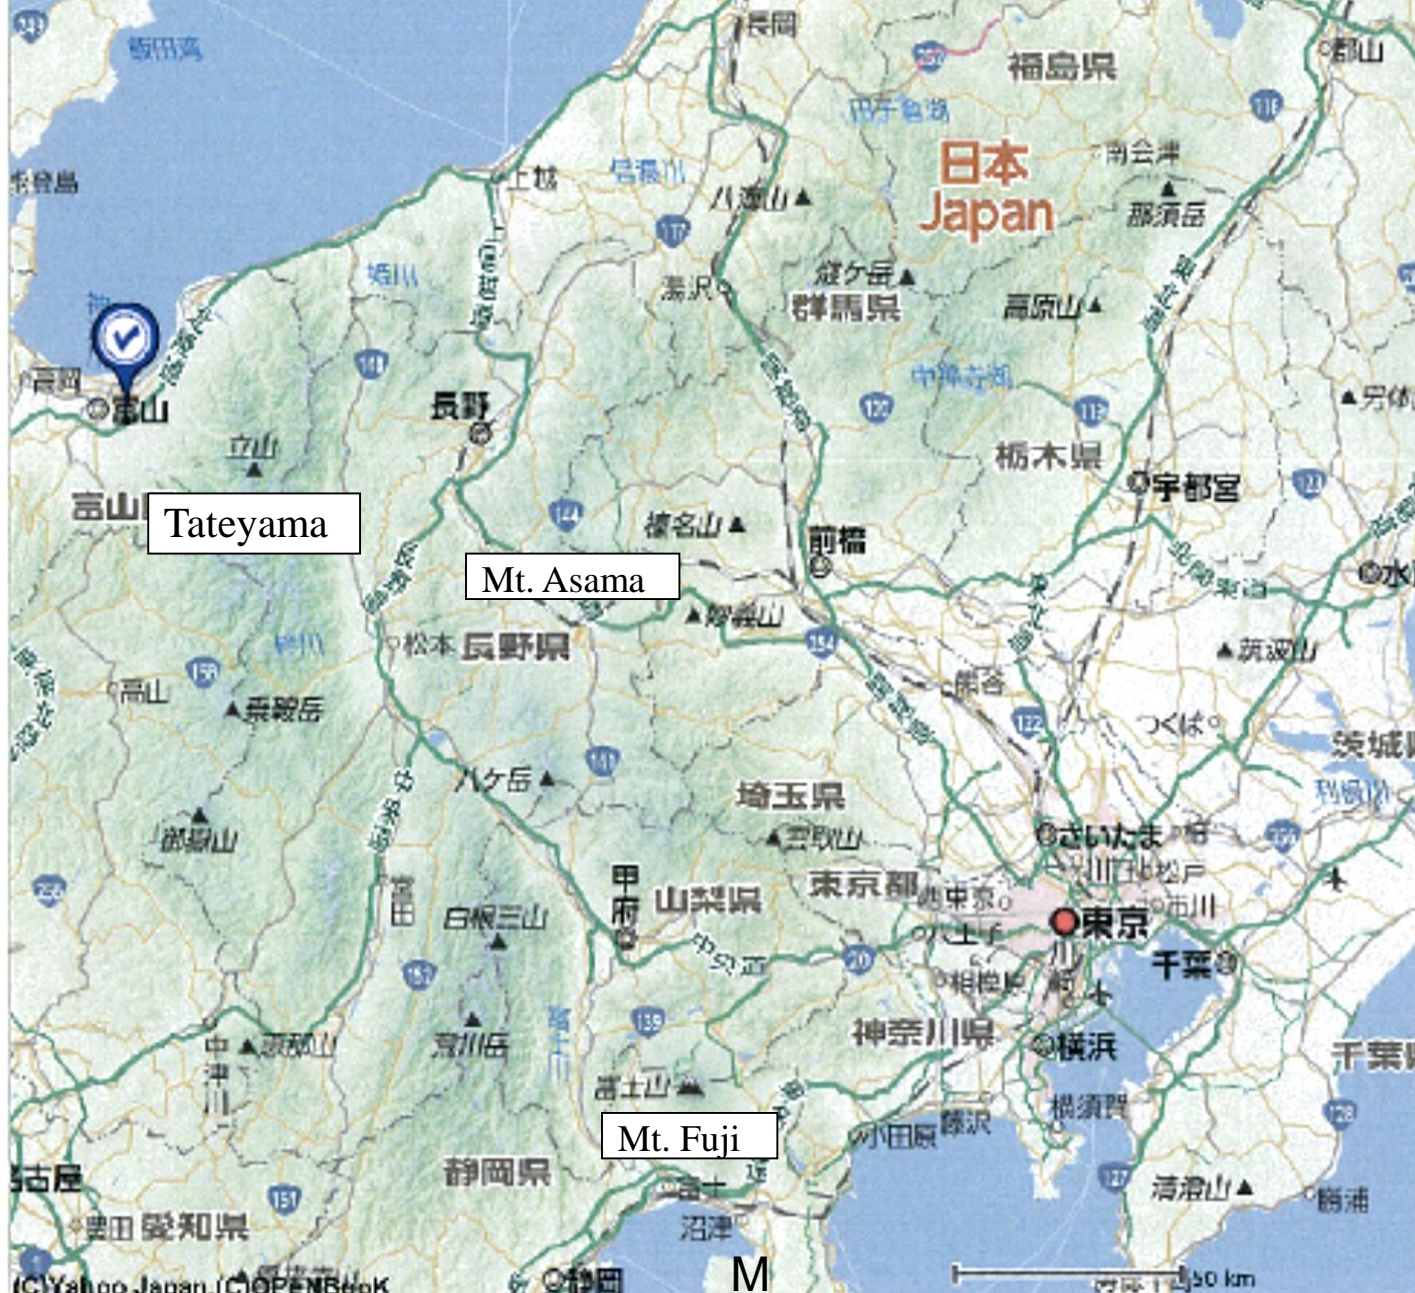
Maps of the Historical Disasters in Japan

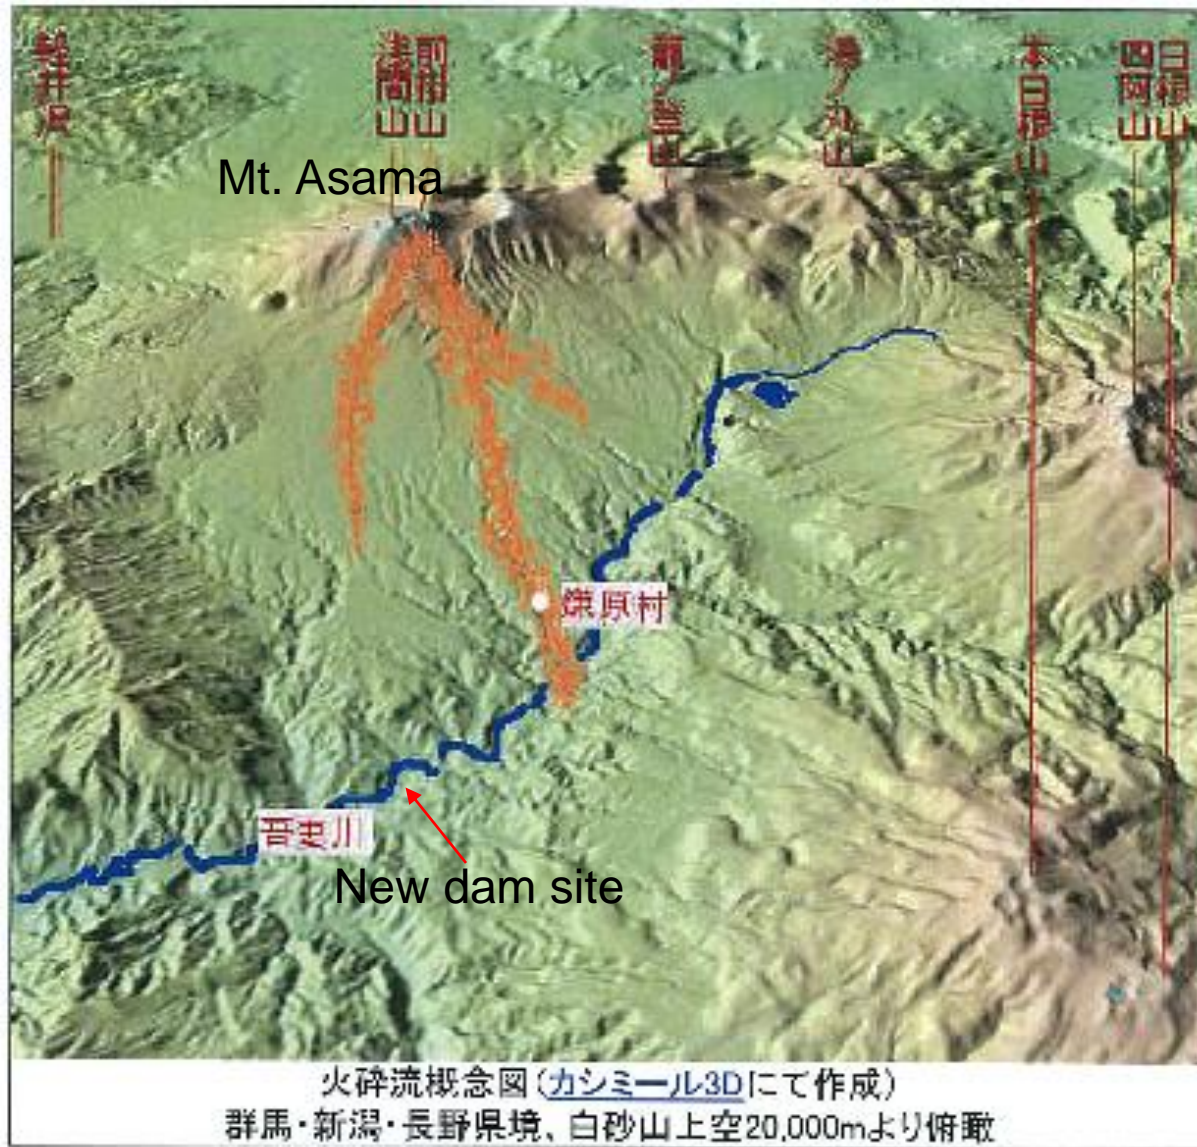
A pyroclastic flow reached Agatsuma River  
formed a natural dam which collapsed.

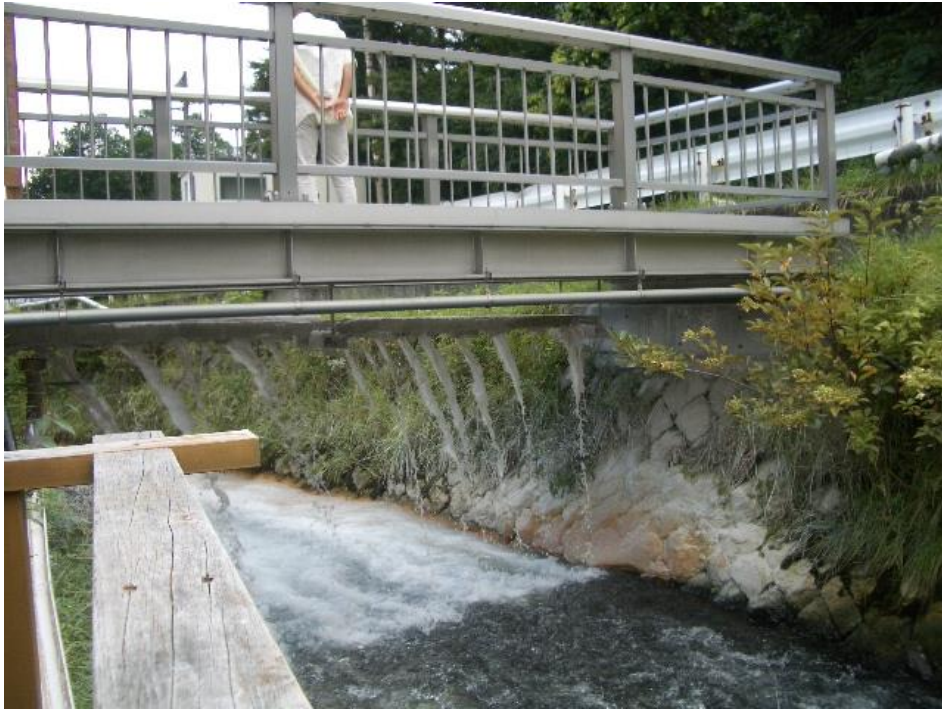
Neutralization using milk of limestone

- The start of neutralization using milk of limestone (セメントミルクによる酸性水中和) allows to **construct a new dam** at Agatsuma river (吾妻川), which is effective for the eruption of Mt. Asama as a sabo-dam (砂防ダム) for pyroclastic flow as well as flood control.
- **Mitigation of disaster risk in Tone river (利根川)** is extremely important, because lost of functions of Metropolitan Tokyo may seriously affect the global economics and politics.

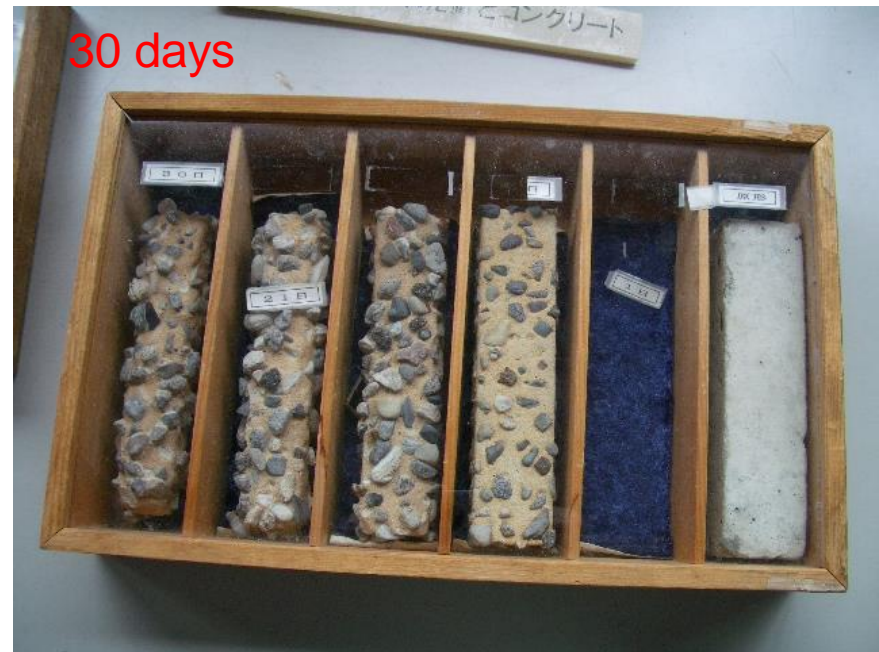
Construction of dam was impossible  
due to highly-acid water

Dissolution of Iron and concrete

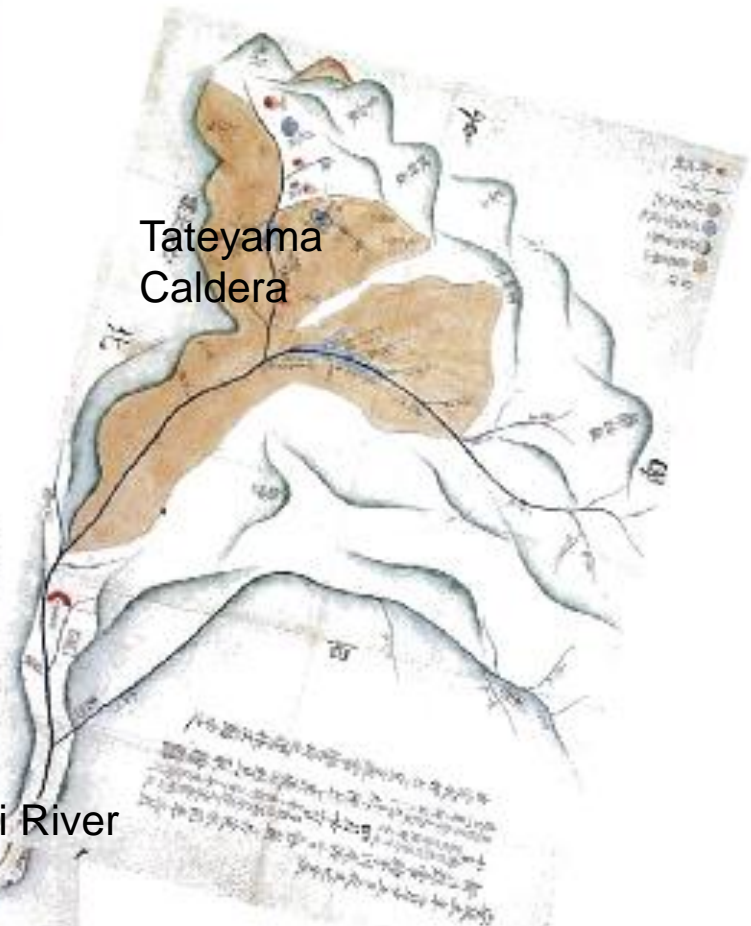
Tateyama  
Caldera

Jyogani River

The Japan Sea

- On Feb. 26, 1858, an earthquake (**Hietsu earthquake, M.7.1~7.2**) produced many land slides, among which a land slide termed **Tonbi Kuzure** in Tateyama volcanic caldera (立山カルデラ) was the largest.
- The land slide produced debris flow, and deposited in the caldera, the volume of which was estimated to be 0.41 billion cubic meters. The debris **produced natural dams**, the longest of which was 8 km, which stored snow-melt water.

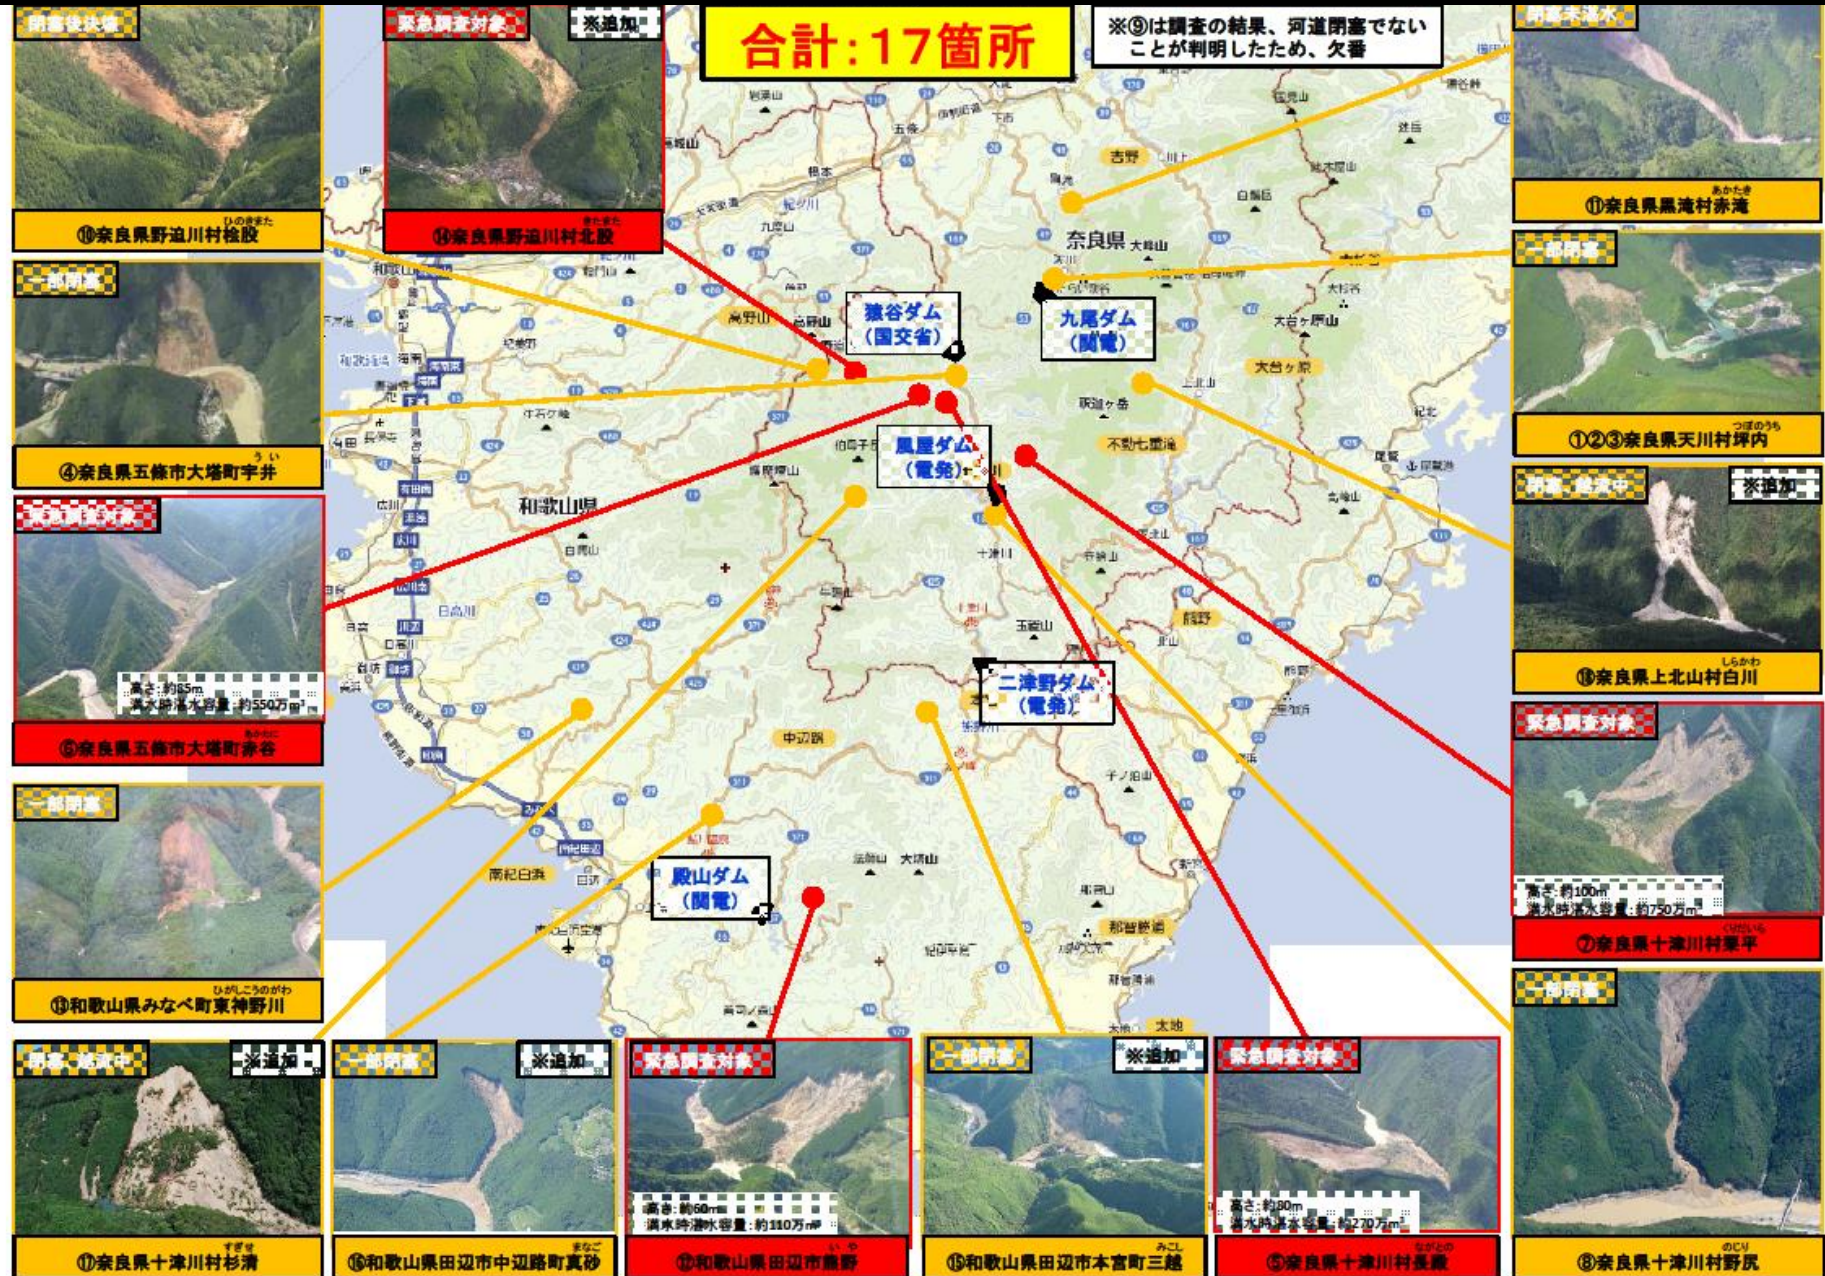
# H23台風12号により紀伊半島に形成された天然ダム

- Heavy rains occurred in 2011 at Kii Peninsula (紀伊半島), which induced land-slide and produced natural dams.
- Land-slides produced 17 natural dams. Stored water was discharged by artificial channels (人工排水路).
- The maximum amount of precipitation almost reached 2,000mm, which is a unusual new record and probably correlated with global warming.
- People lost are 92.
