10th Joint Symposium on Disaster Risk Management
September 28, 2016

**Liquefaction Damage
in Chiba, Japan
due to the 2011 Tohoku Earthquake**

**Shoichi Nakai
Chiba University**

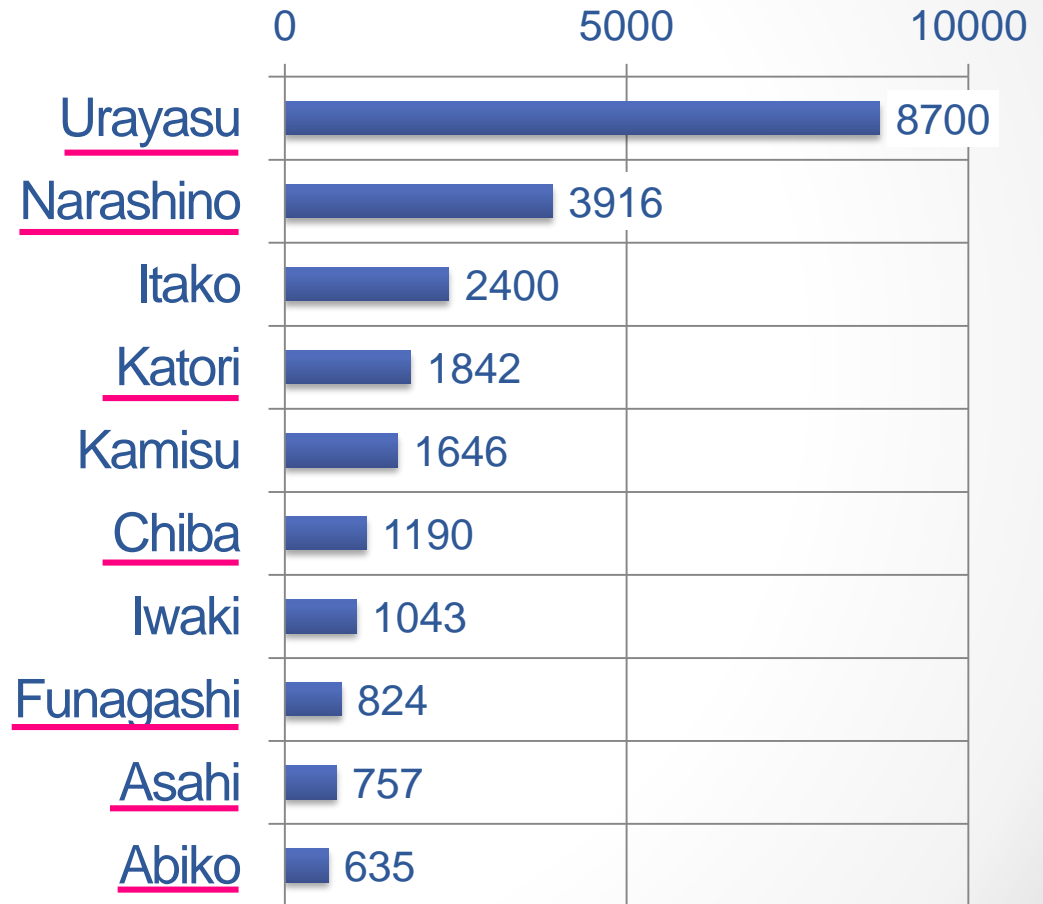
Damaged Houses due to Liquefaction

Prefecture	# of Houses
Iwate	3
Miyagi	140
Fukushima	1,043
Ibaraki	6,751
Gunma	1
Saitama	175
Chiba	18,674
Tokyo	56
Kanagawa	71
Total	26,914

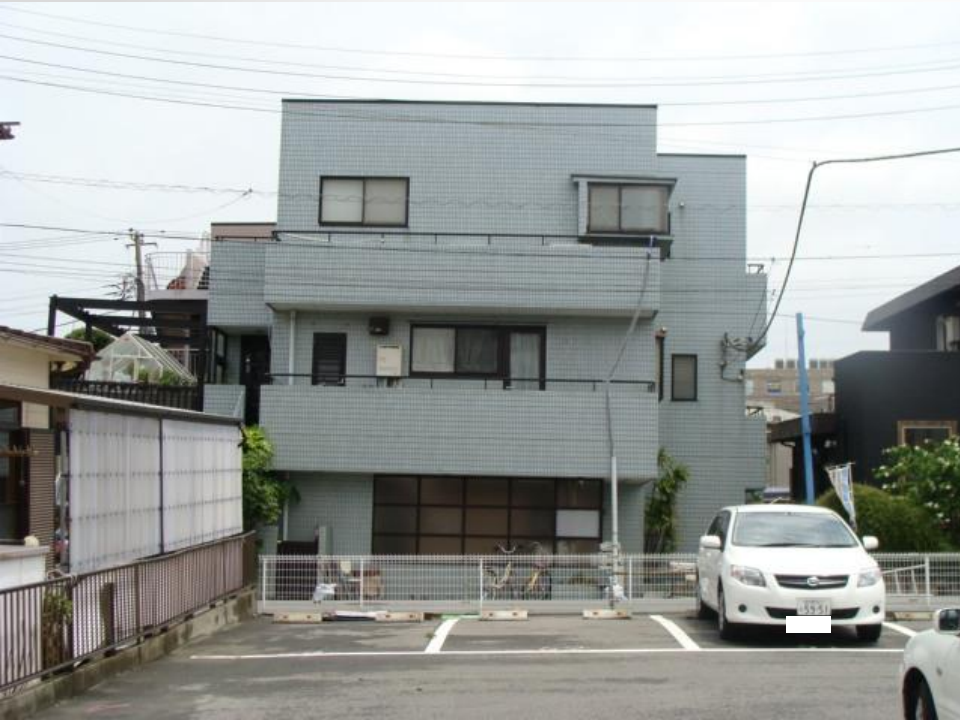
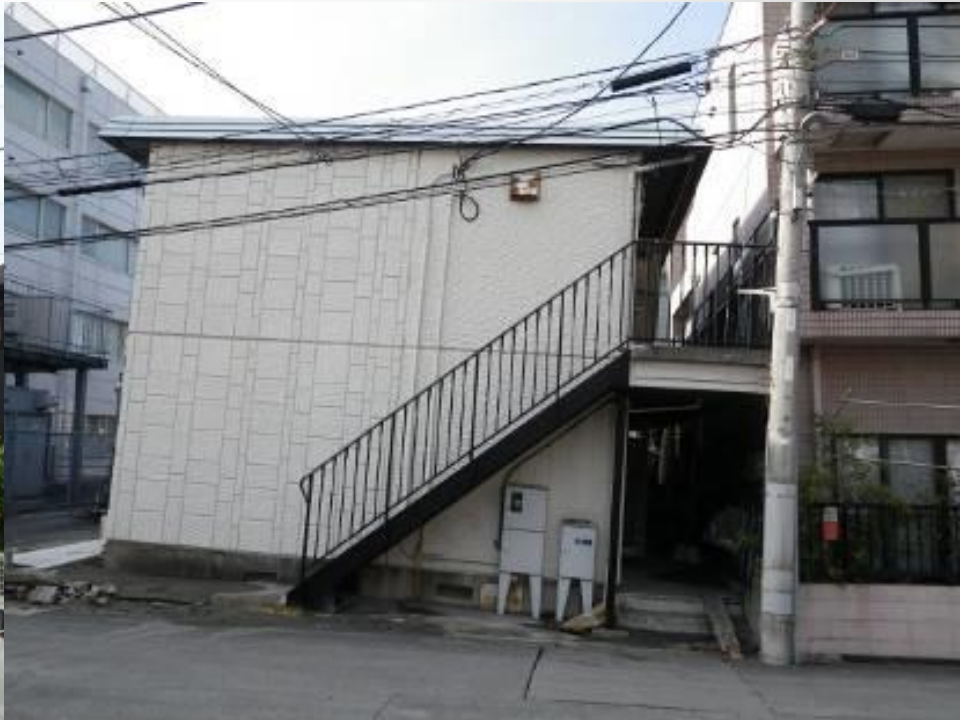
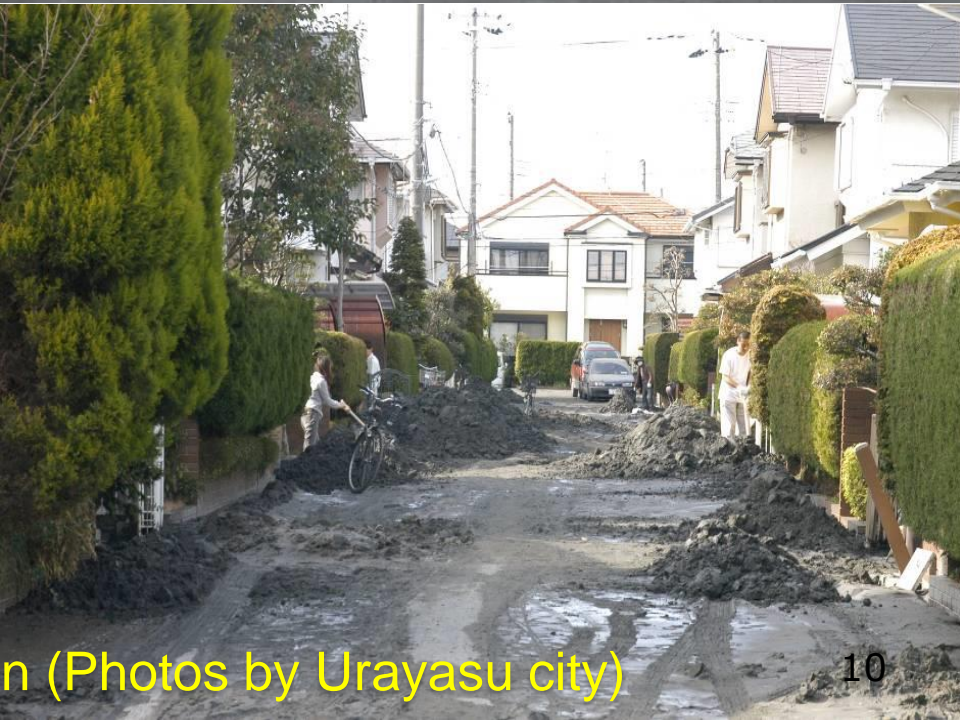
Damage due to liquefaction (Photos by Urayasu city)

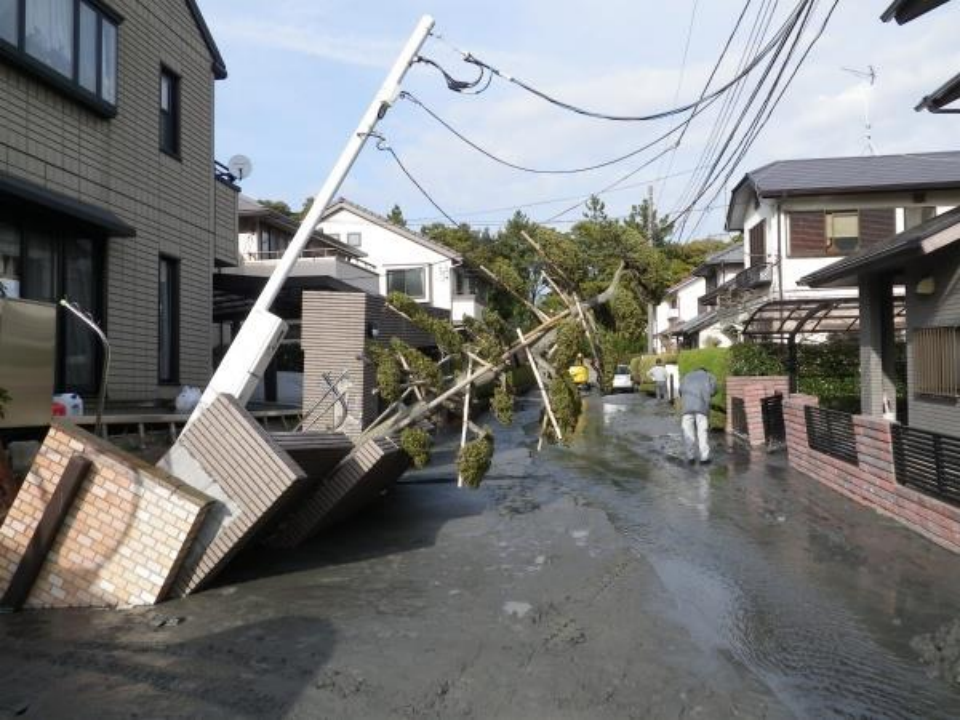
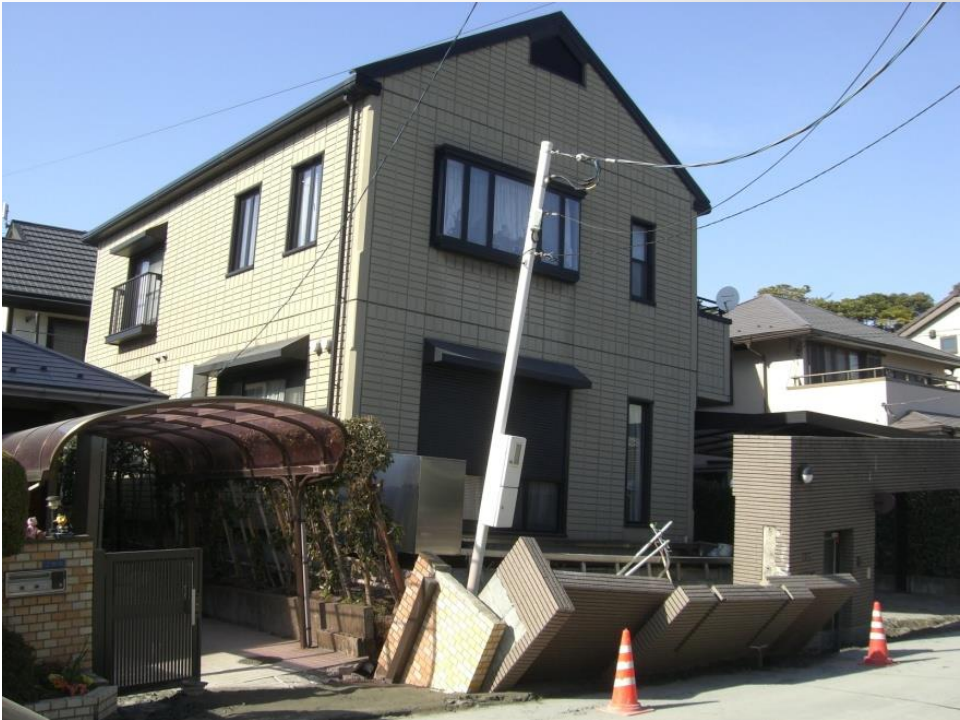
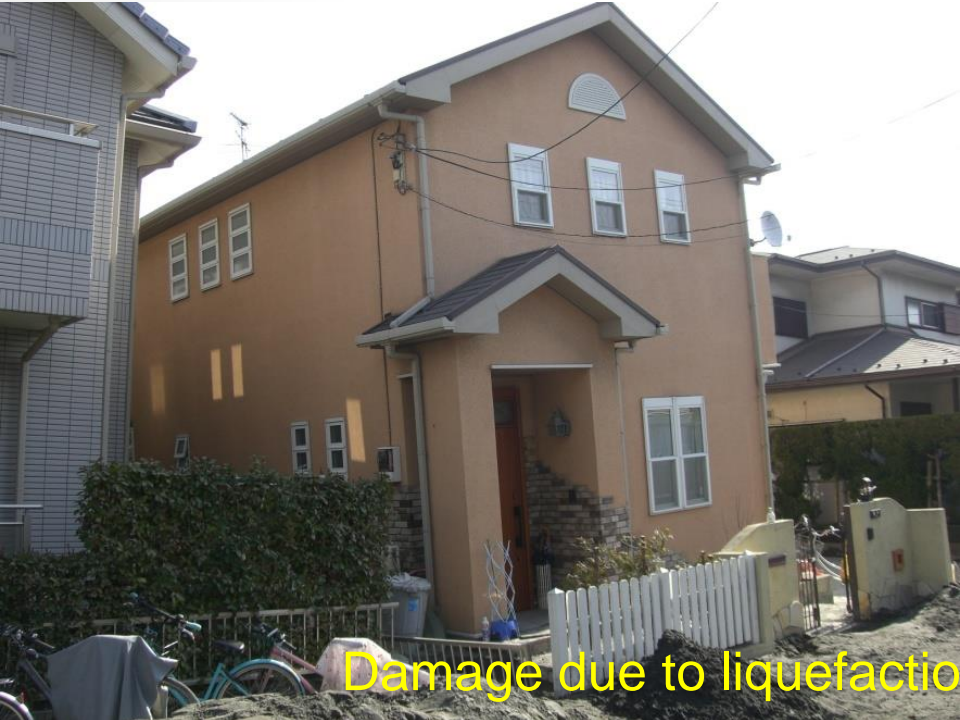
Damage due to liquefaction (Photos by Urayasu city)

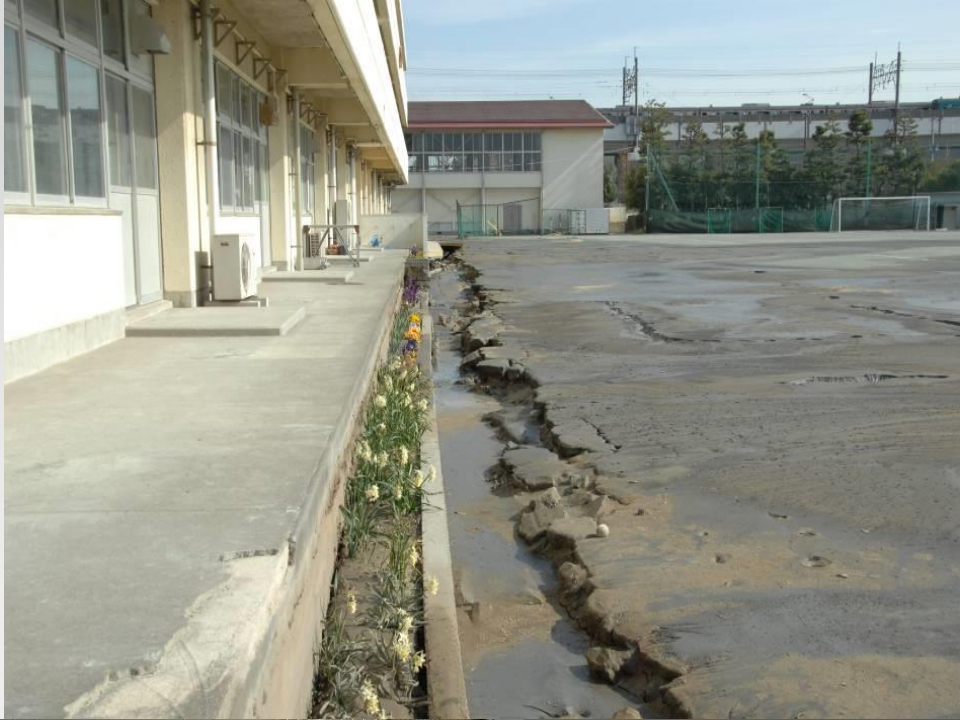
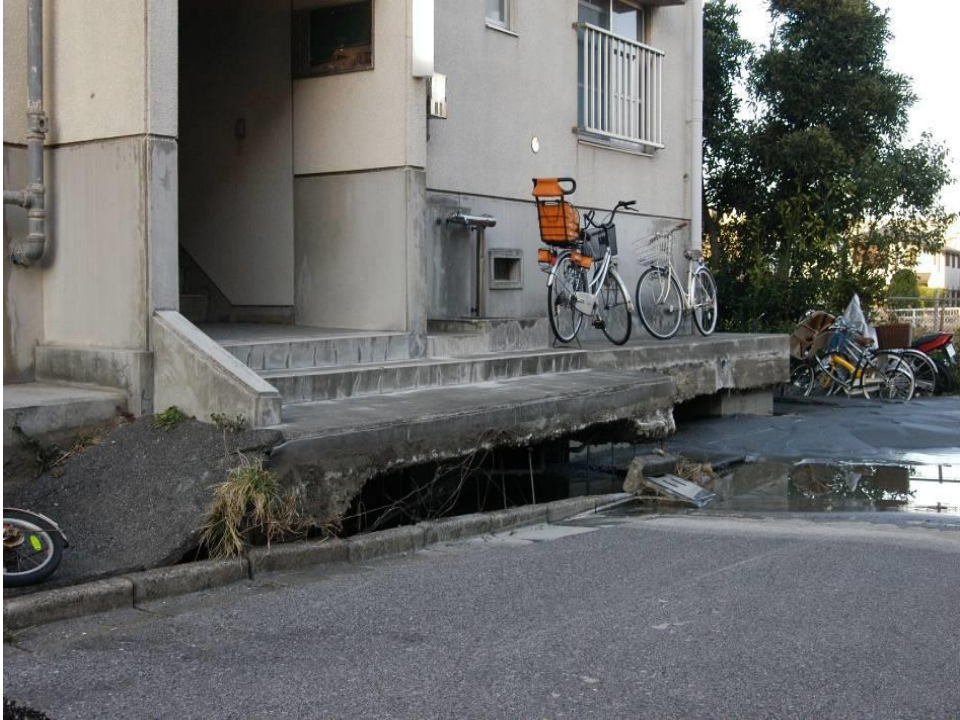
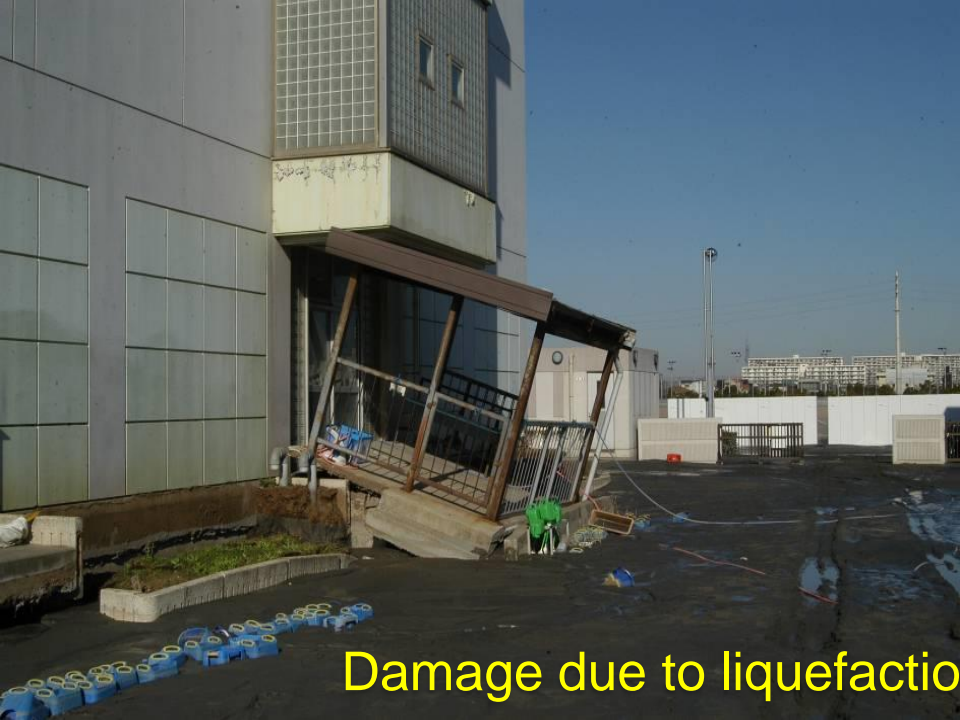
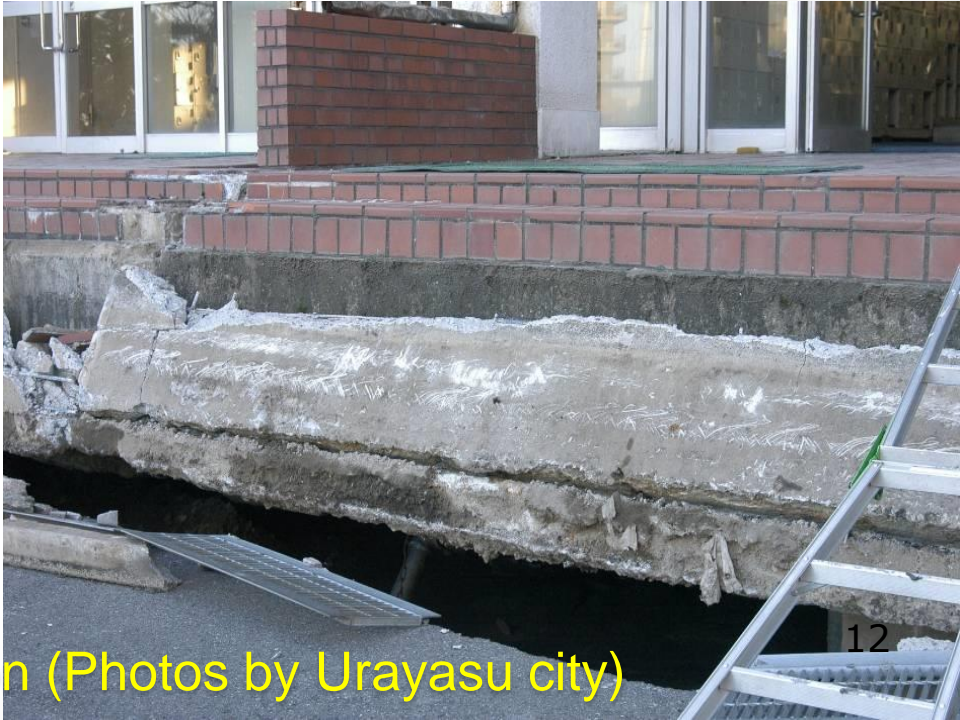
Damage due to liquefaction (Photos by Urayasu city)

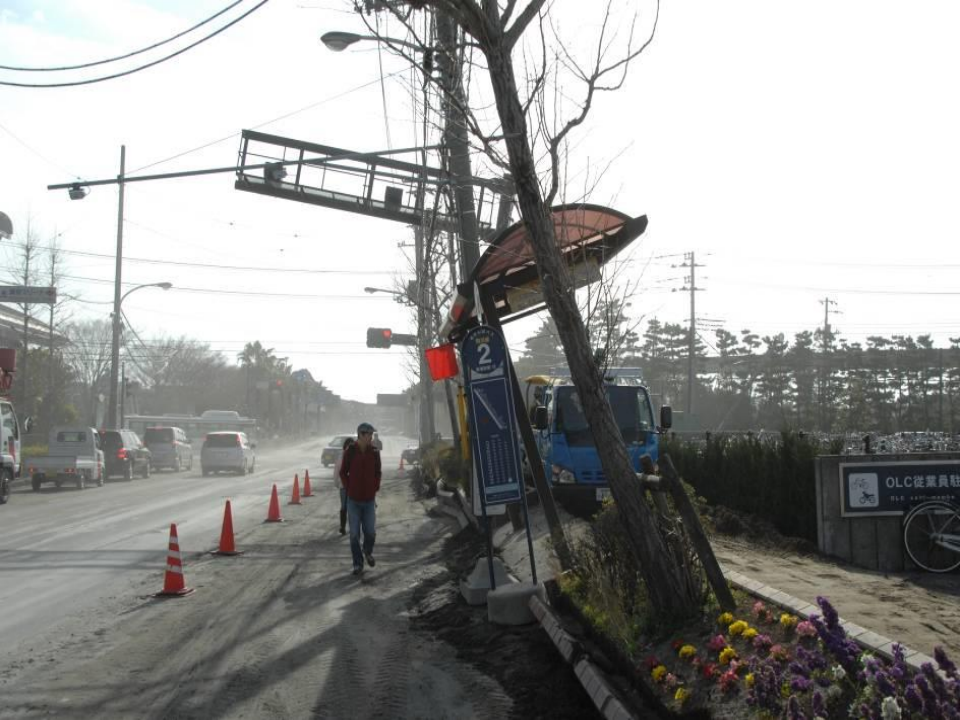
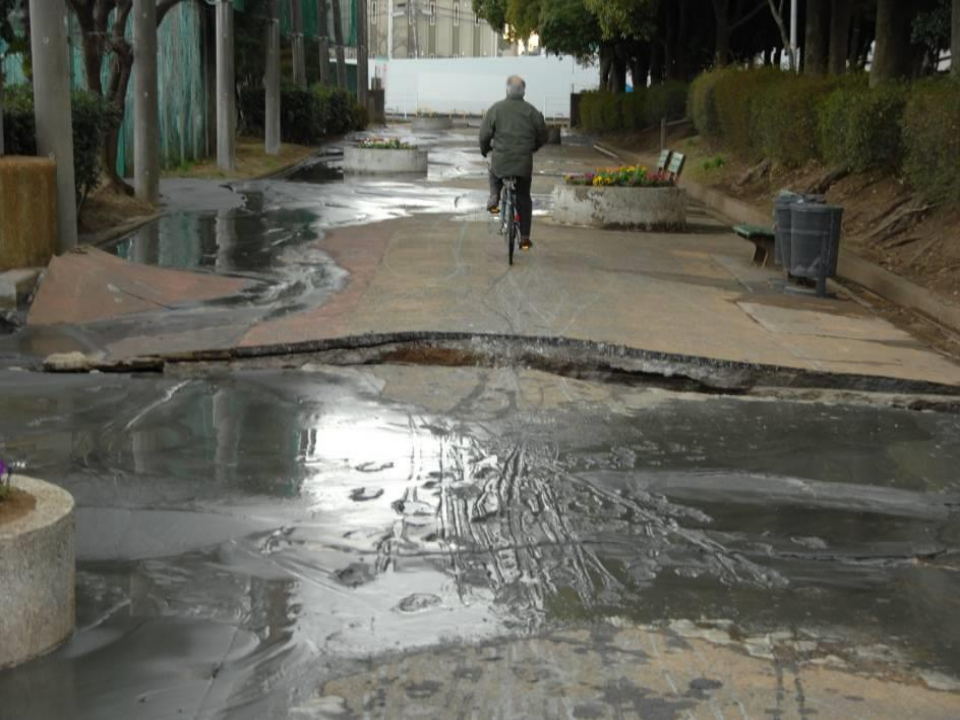
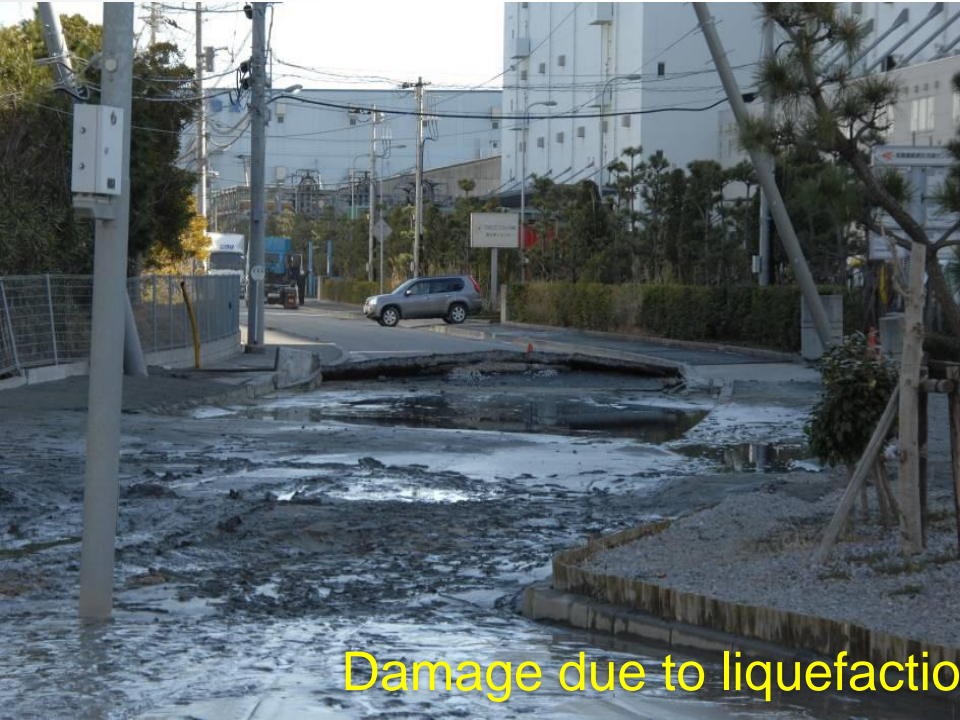
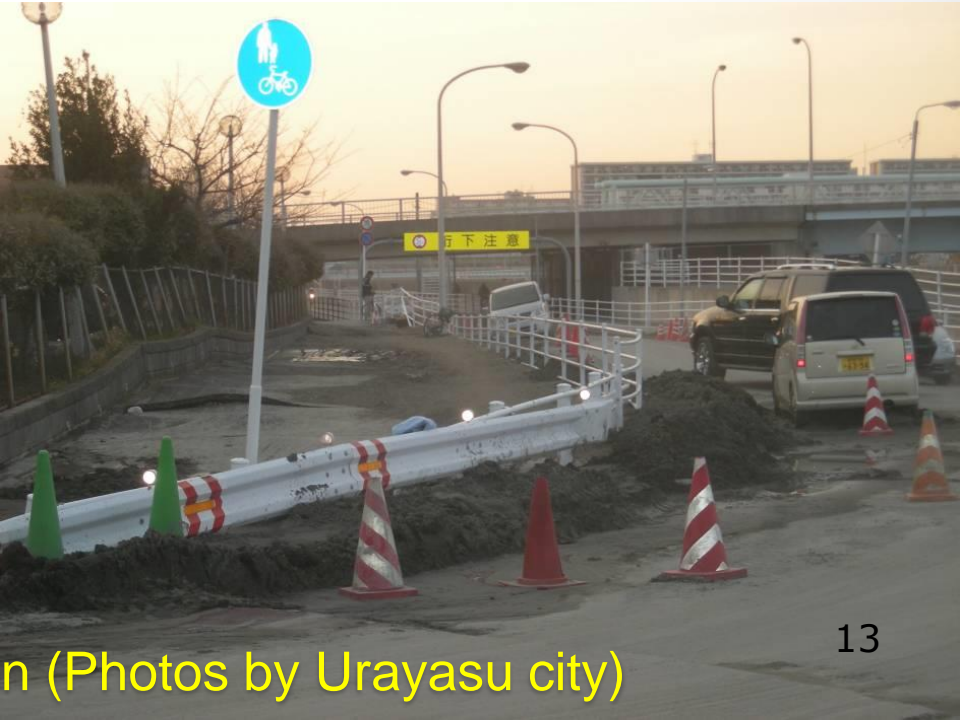
Damage due to liquefaction (Photos by Urayasu city)

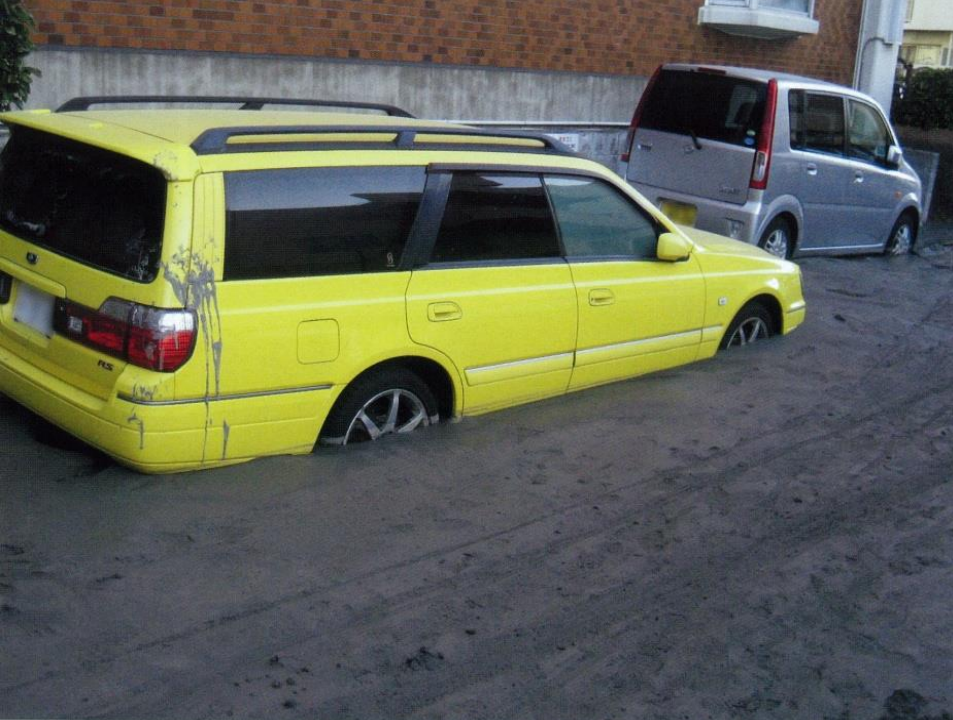
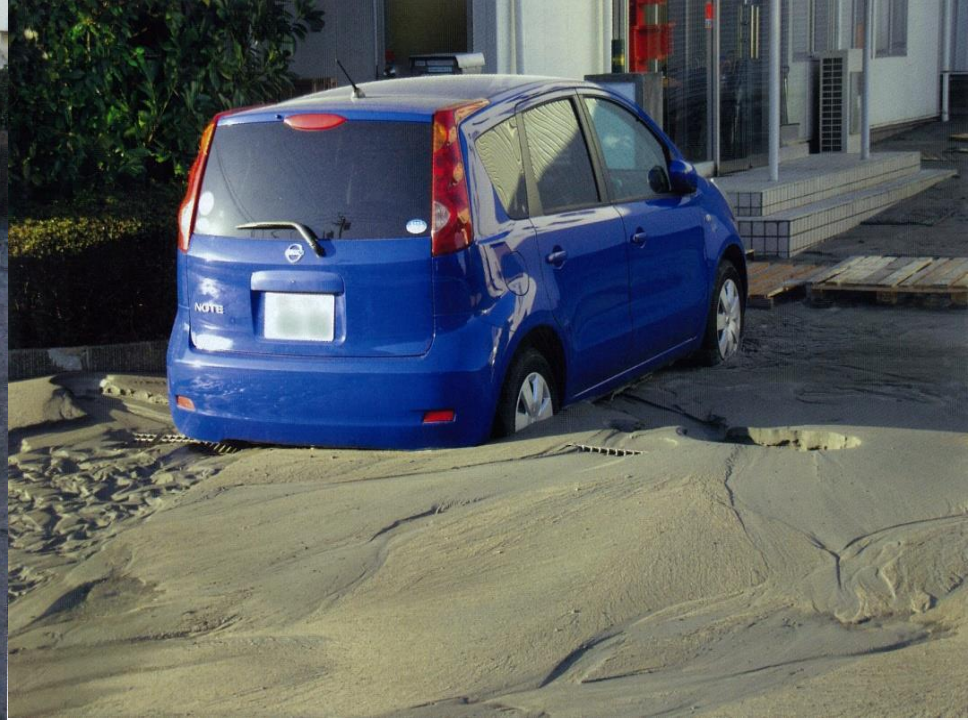
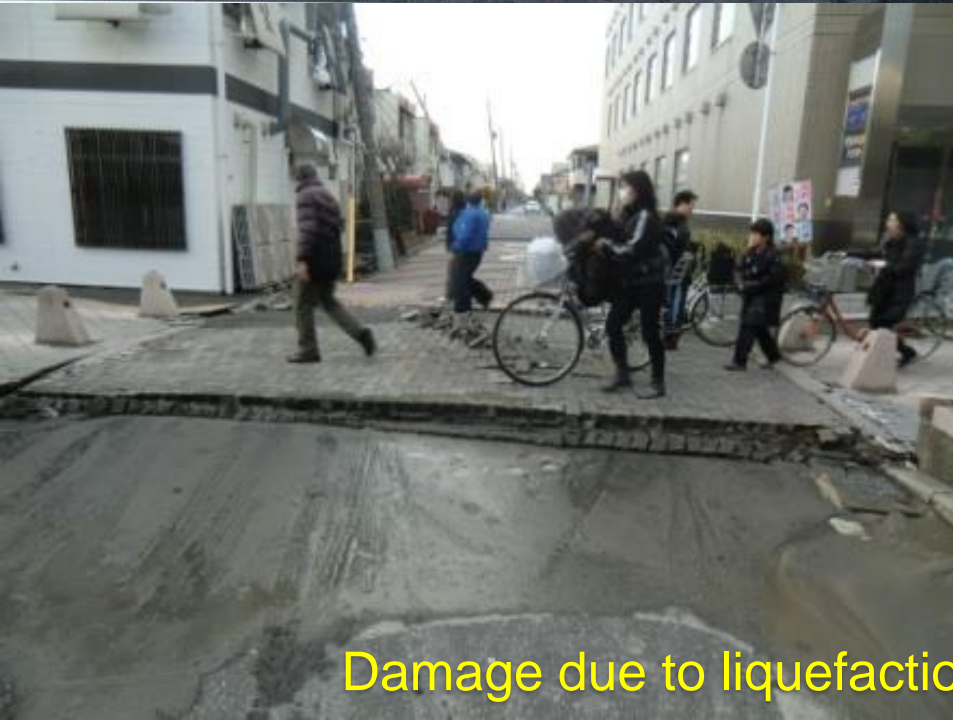
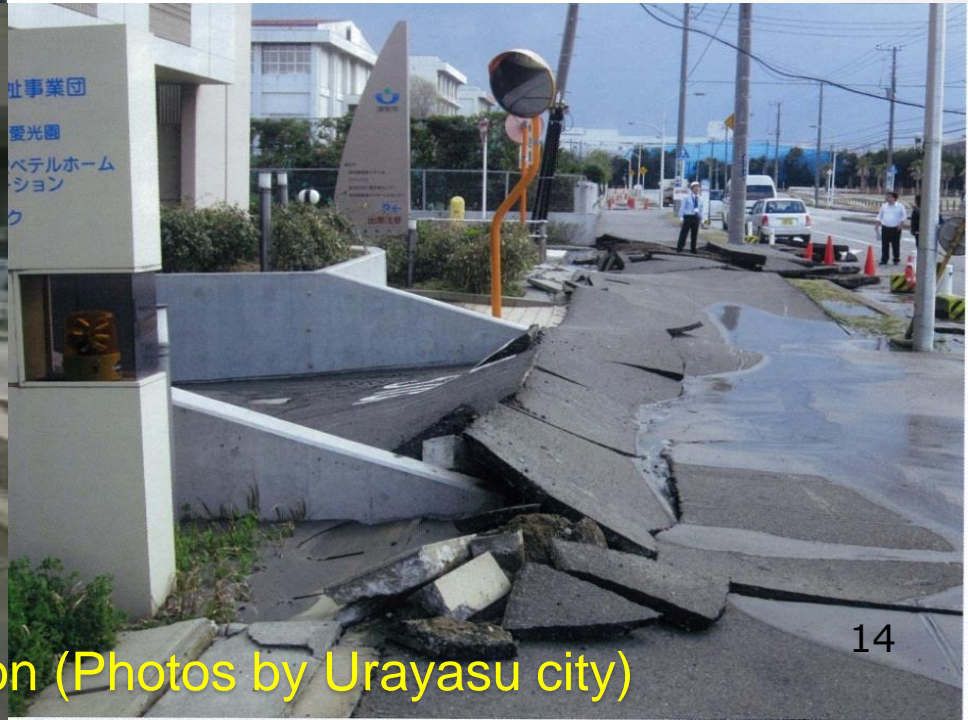
Damage due to liquefaction (Photos by Urayasu city)

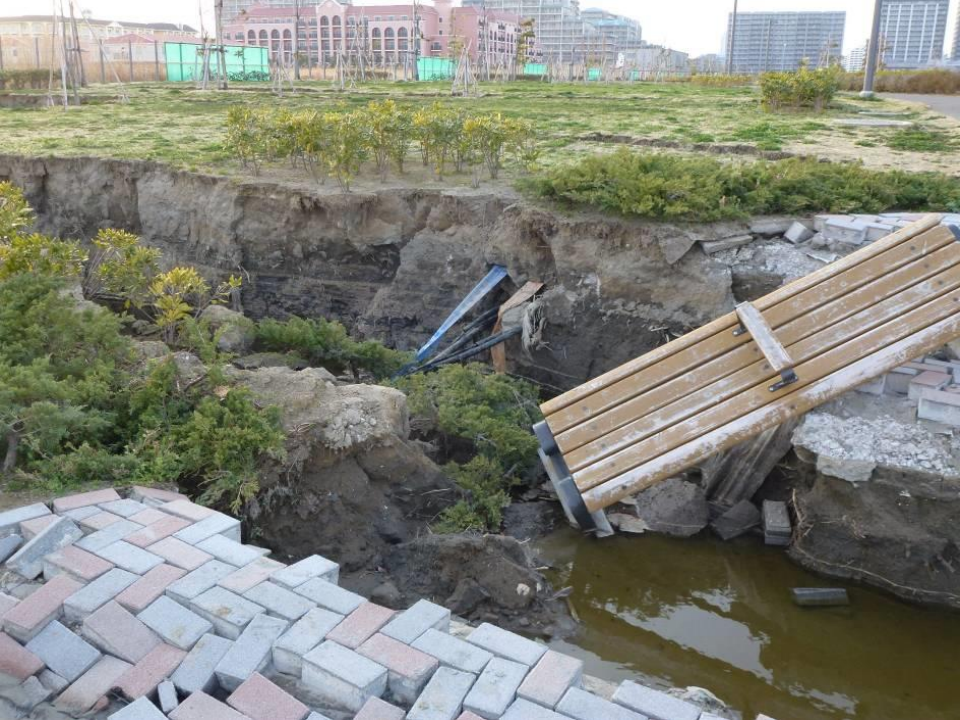
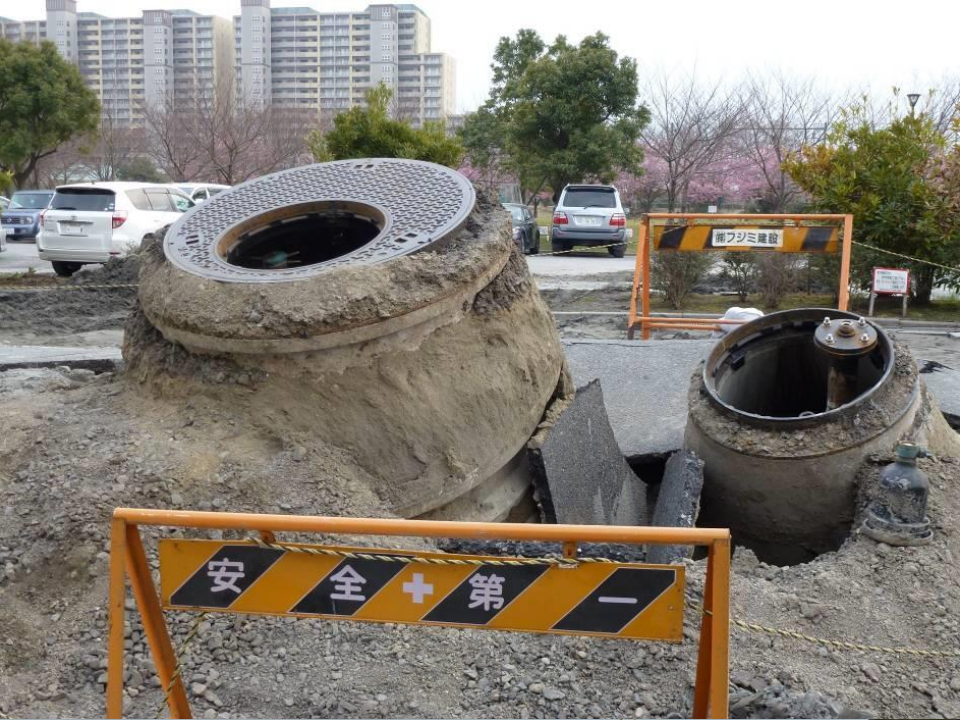
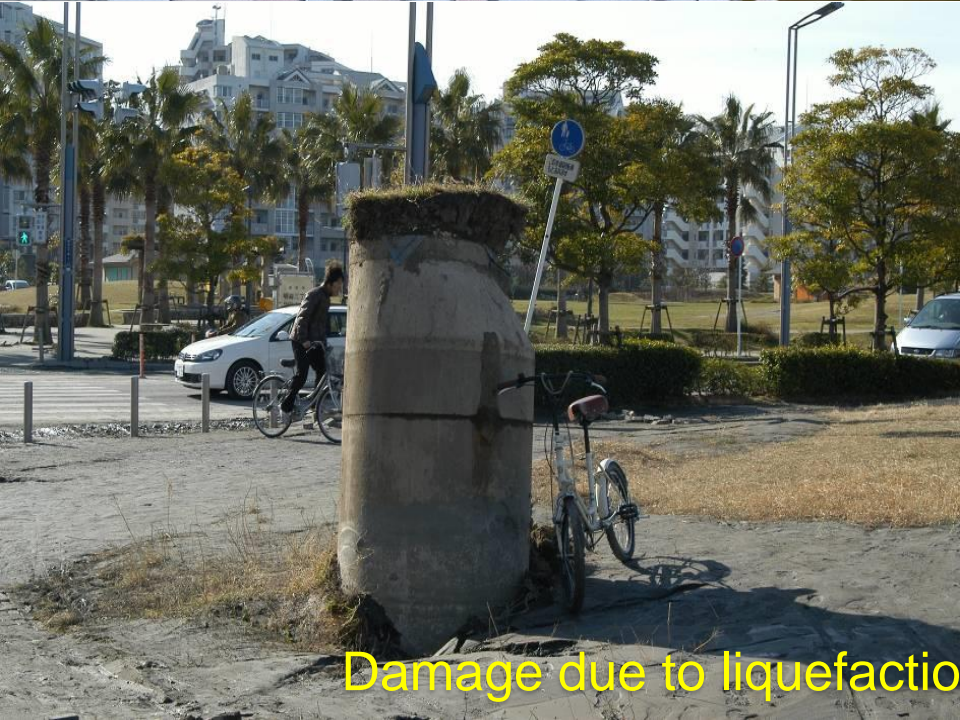
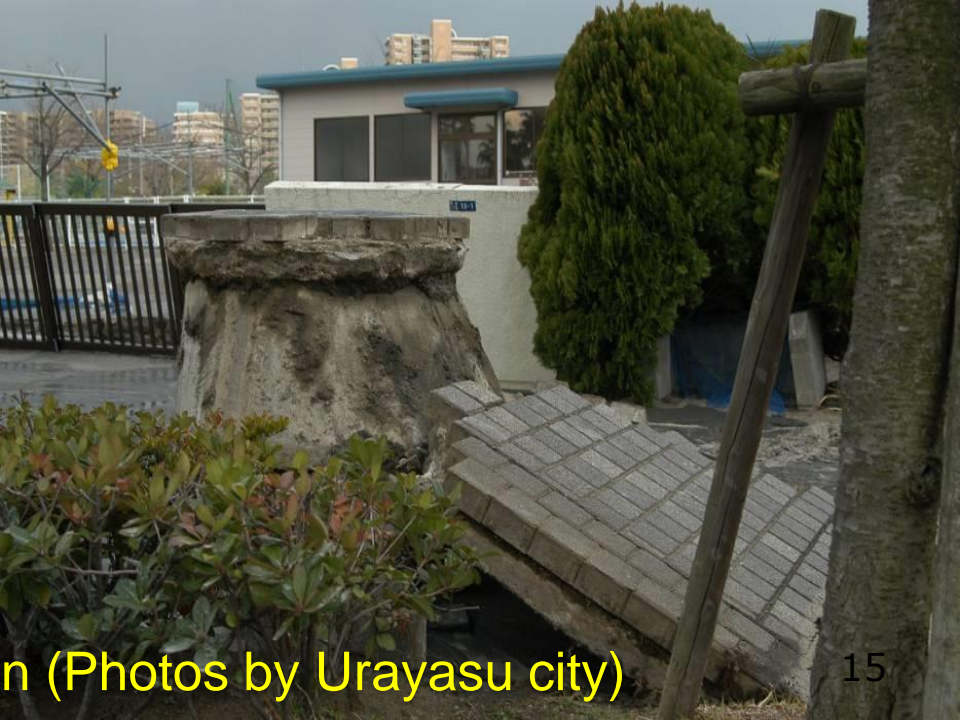
Damage due to liquefaction (Photos by Urayasu city)

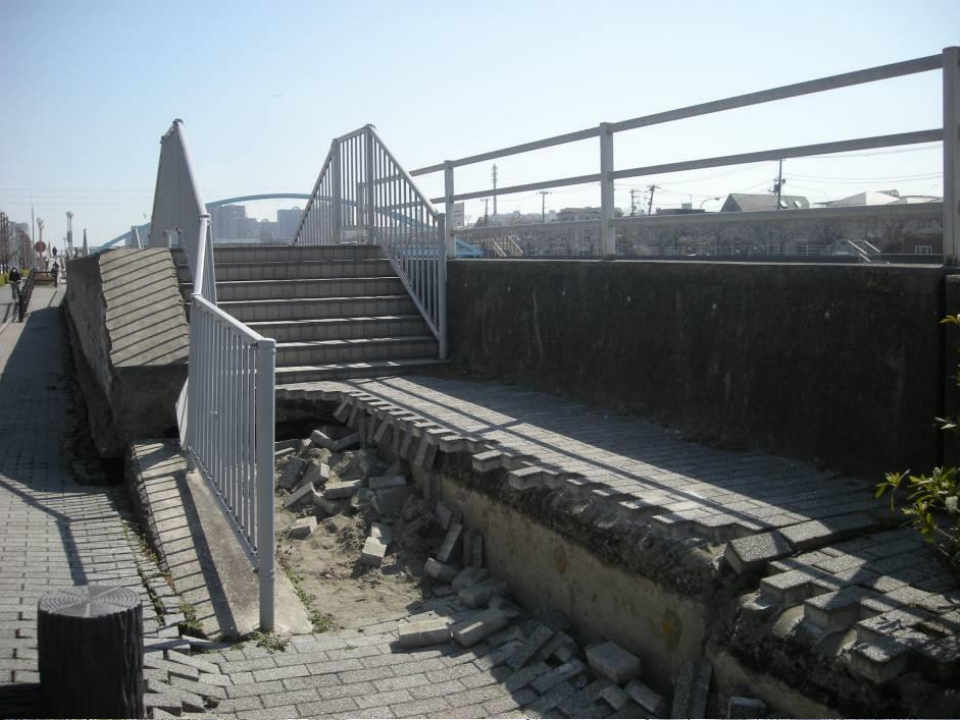
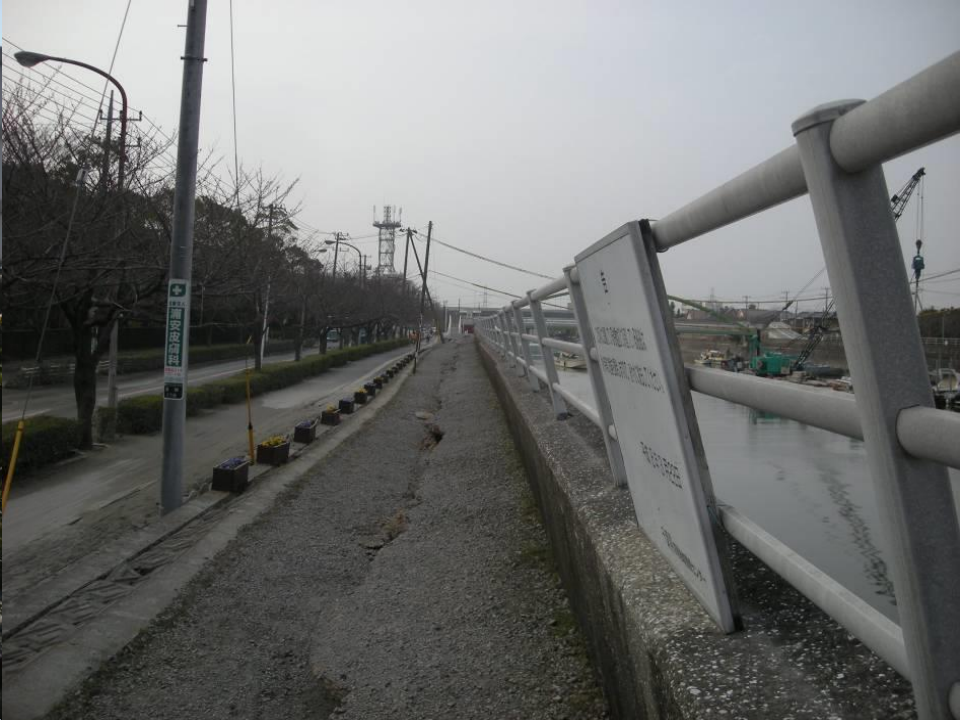
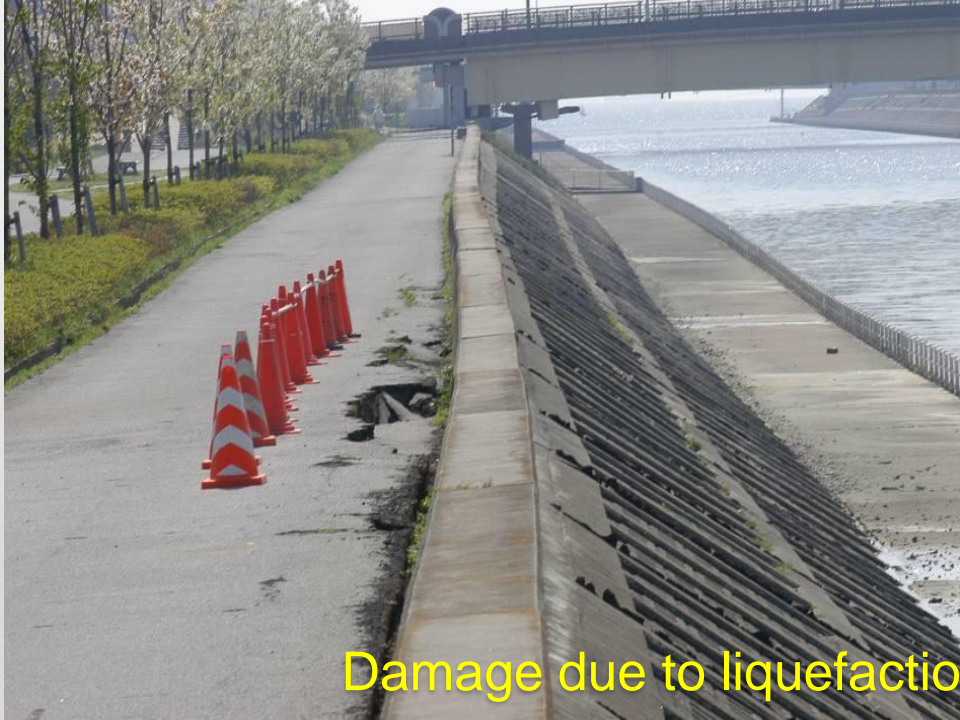
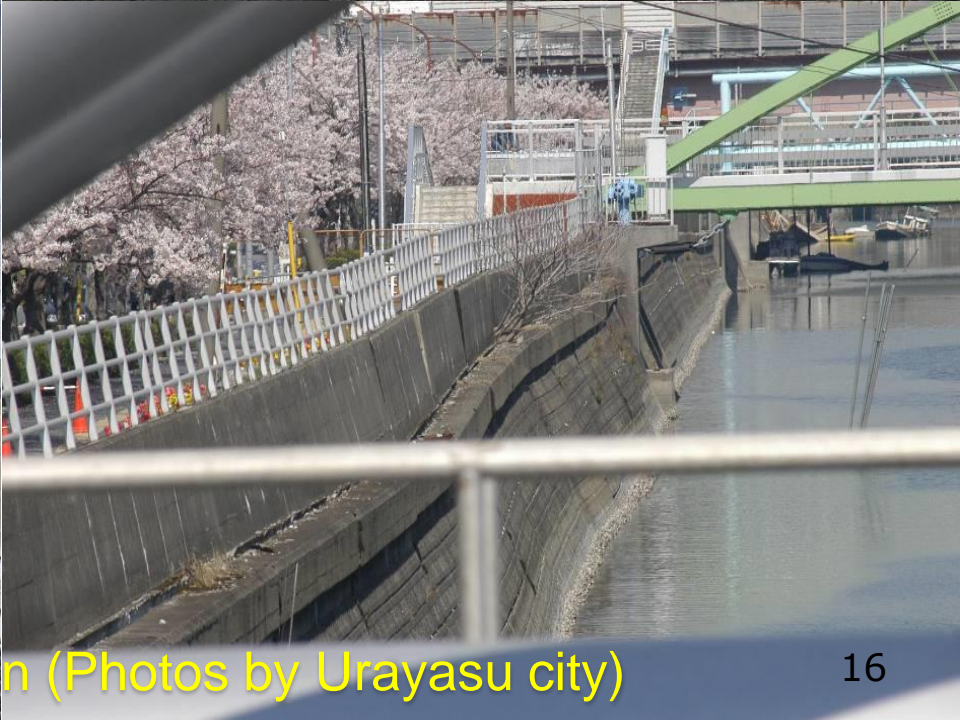
Damage due to liquefaction (Photos by Urayasu city)

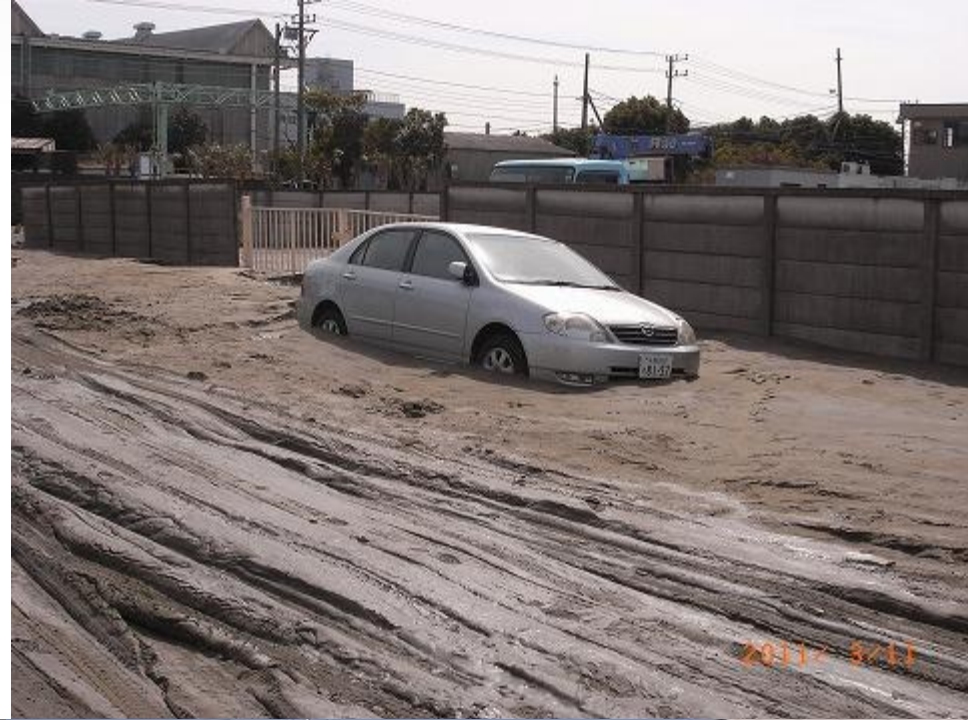
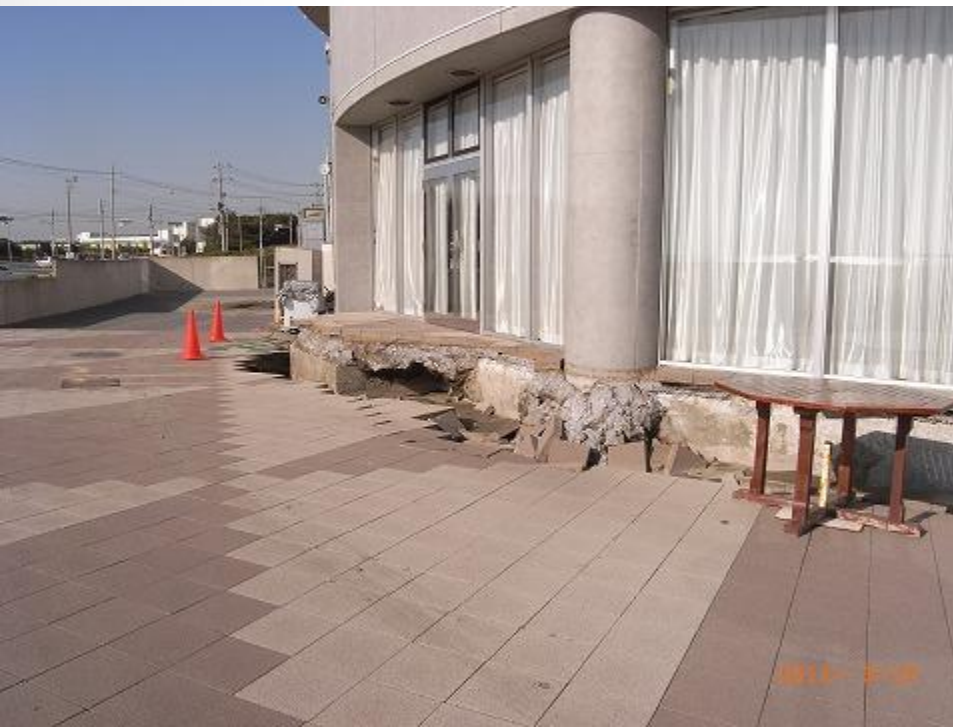
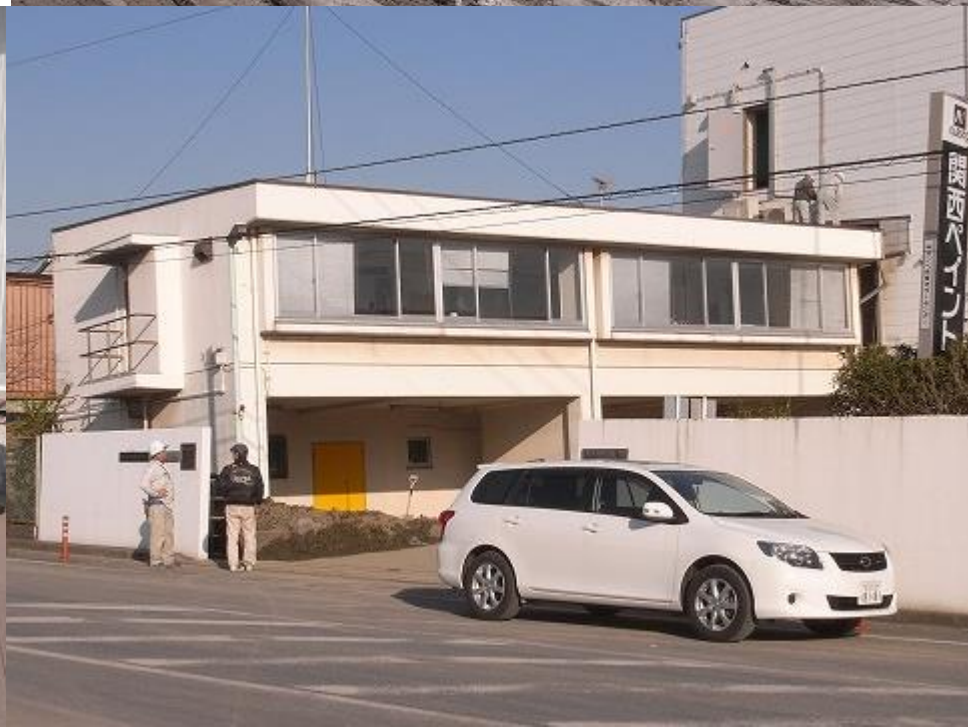
Kaihin- Makukhari (Business Dist.)

Isobe

(Residential Area)

Thickness : 45cm

Shin-Minato (Industrial Area)

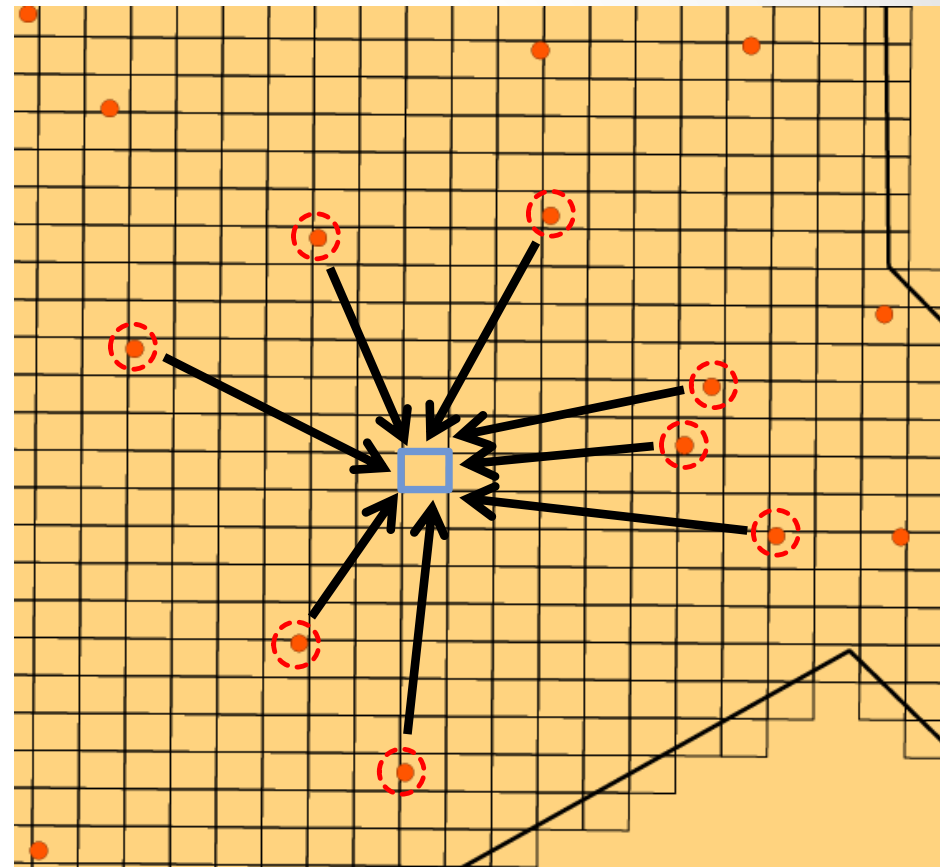
Construction of Soil Model

● Boring Log

Soil Type and SPT-N :

Weighted average of surrounding 8 boring logs

Soil Model
