10th Joint Symposium on Disaster Risk Management
September 28, 2016

**Liquefaction Damage
in Chiba, Japan
due to the 2011 Tohoku Earthquake**

**Shoichi Nakai
Chiba University**

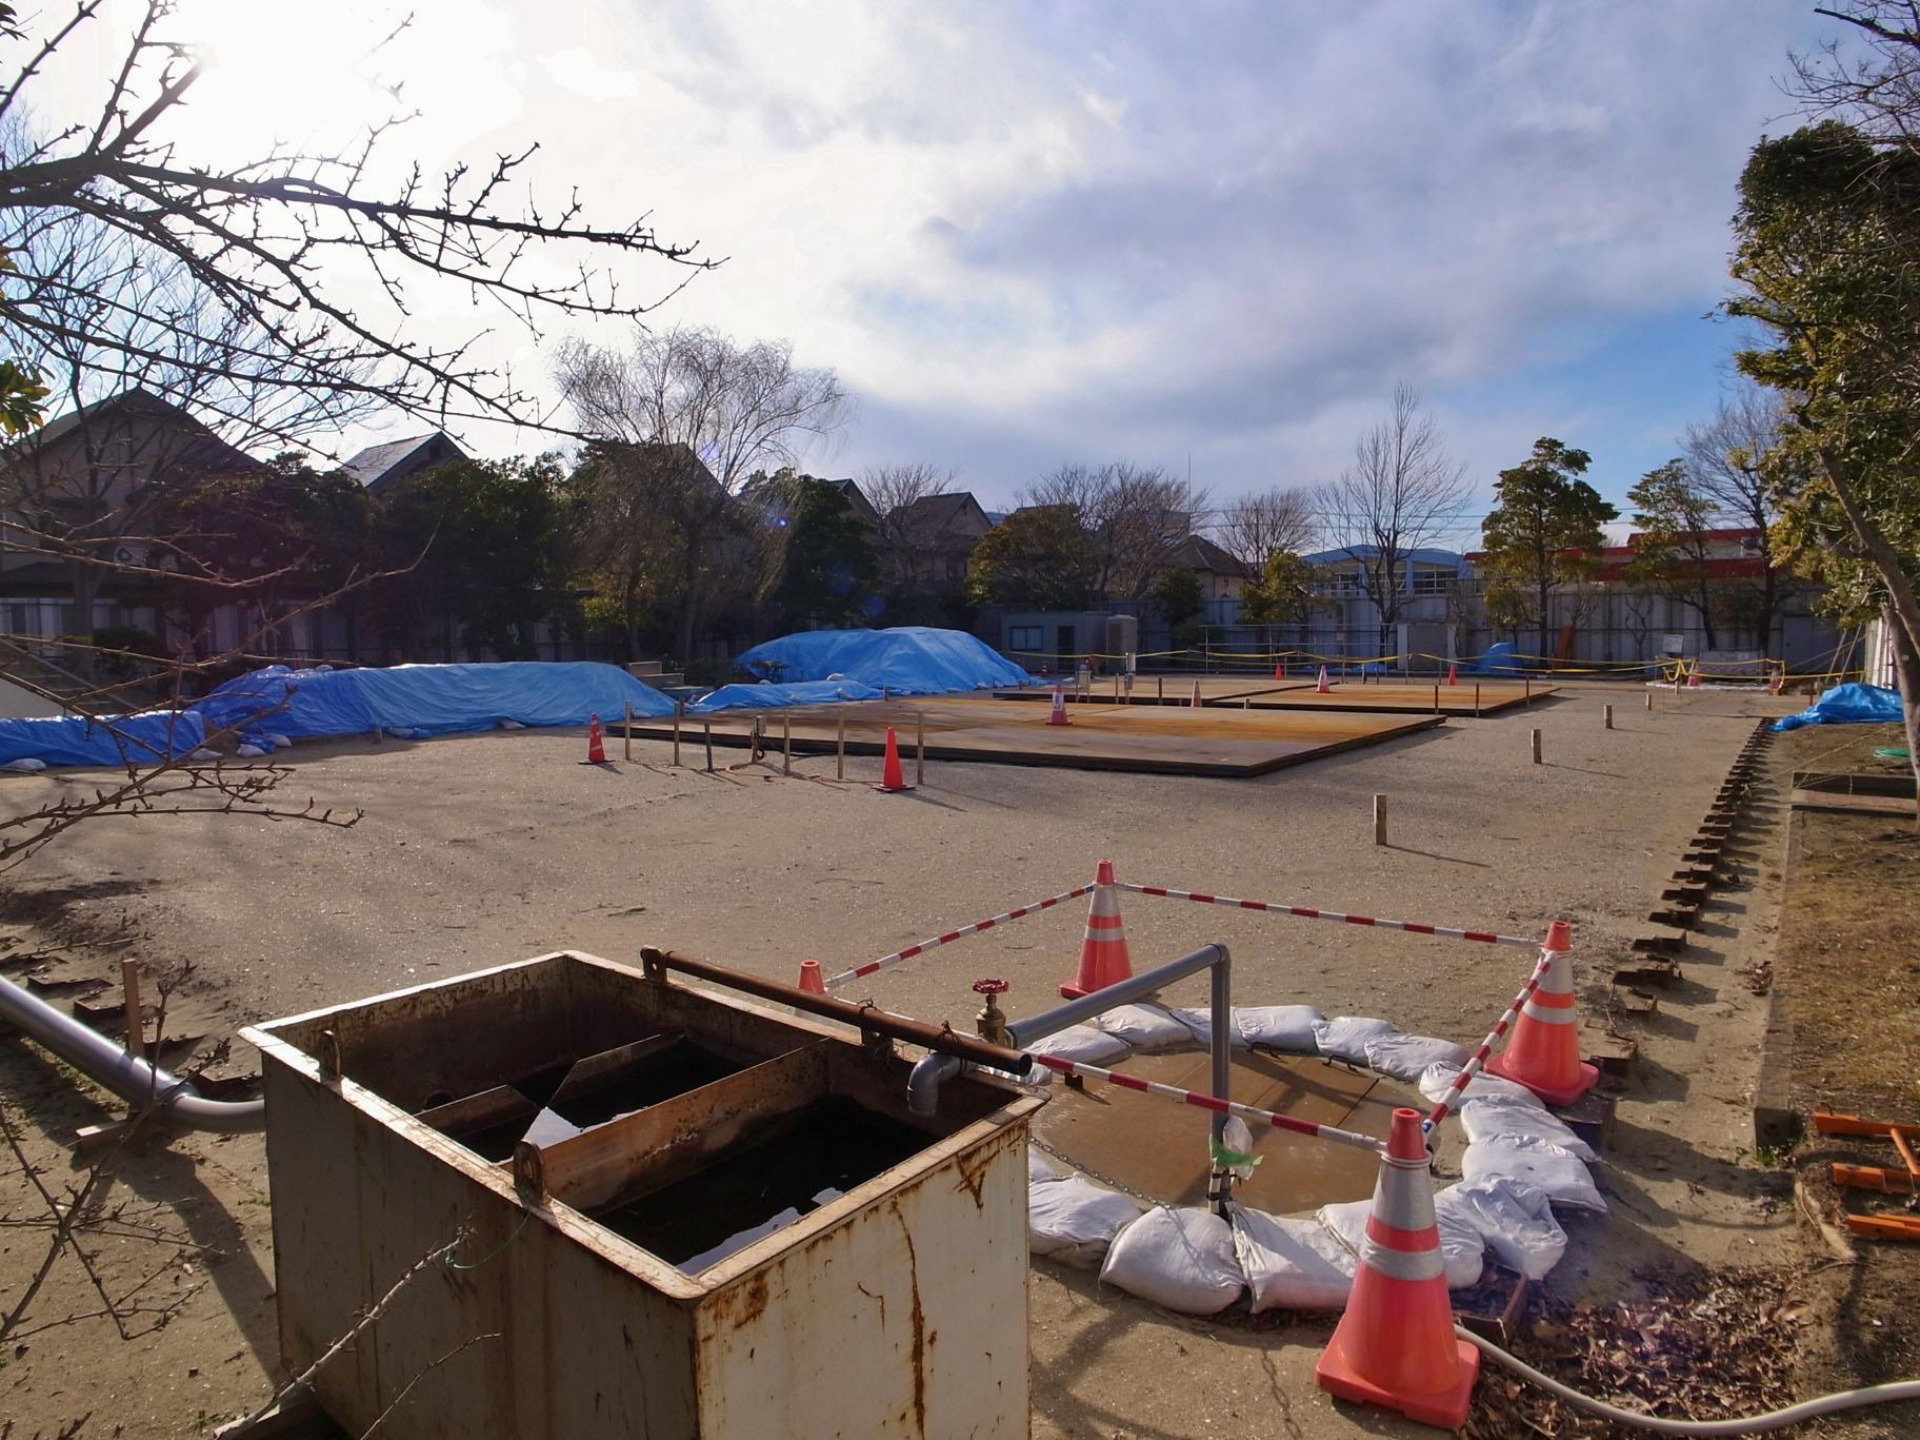
Residential House Models

Upper: Plan, Lower: Section

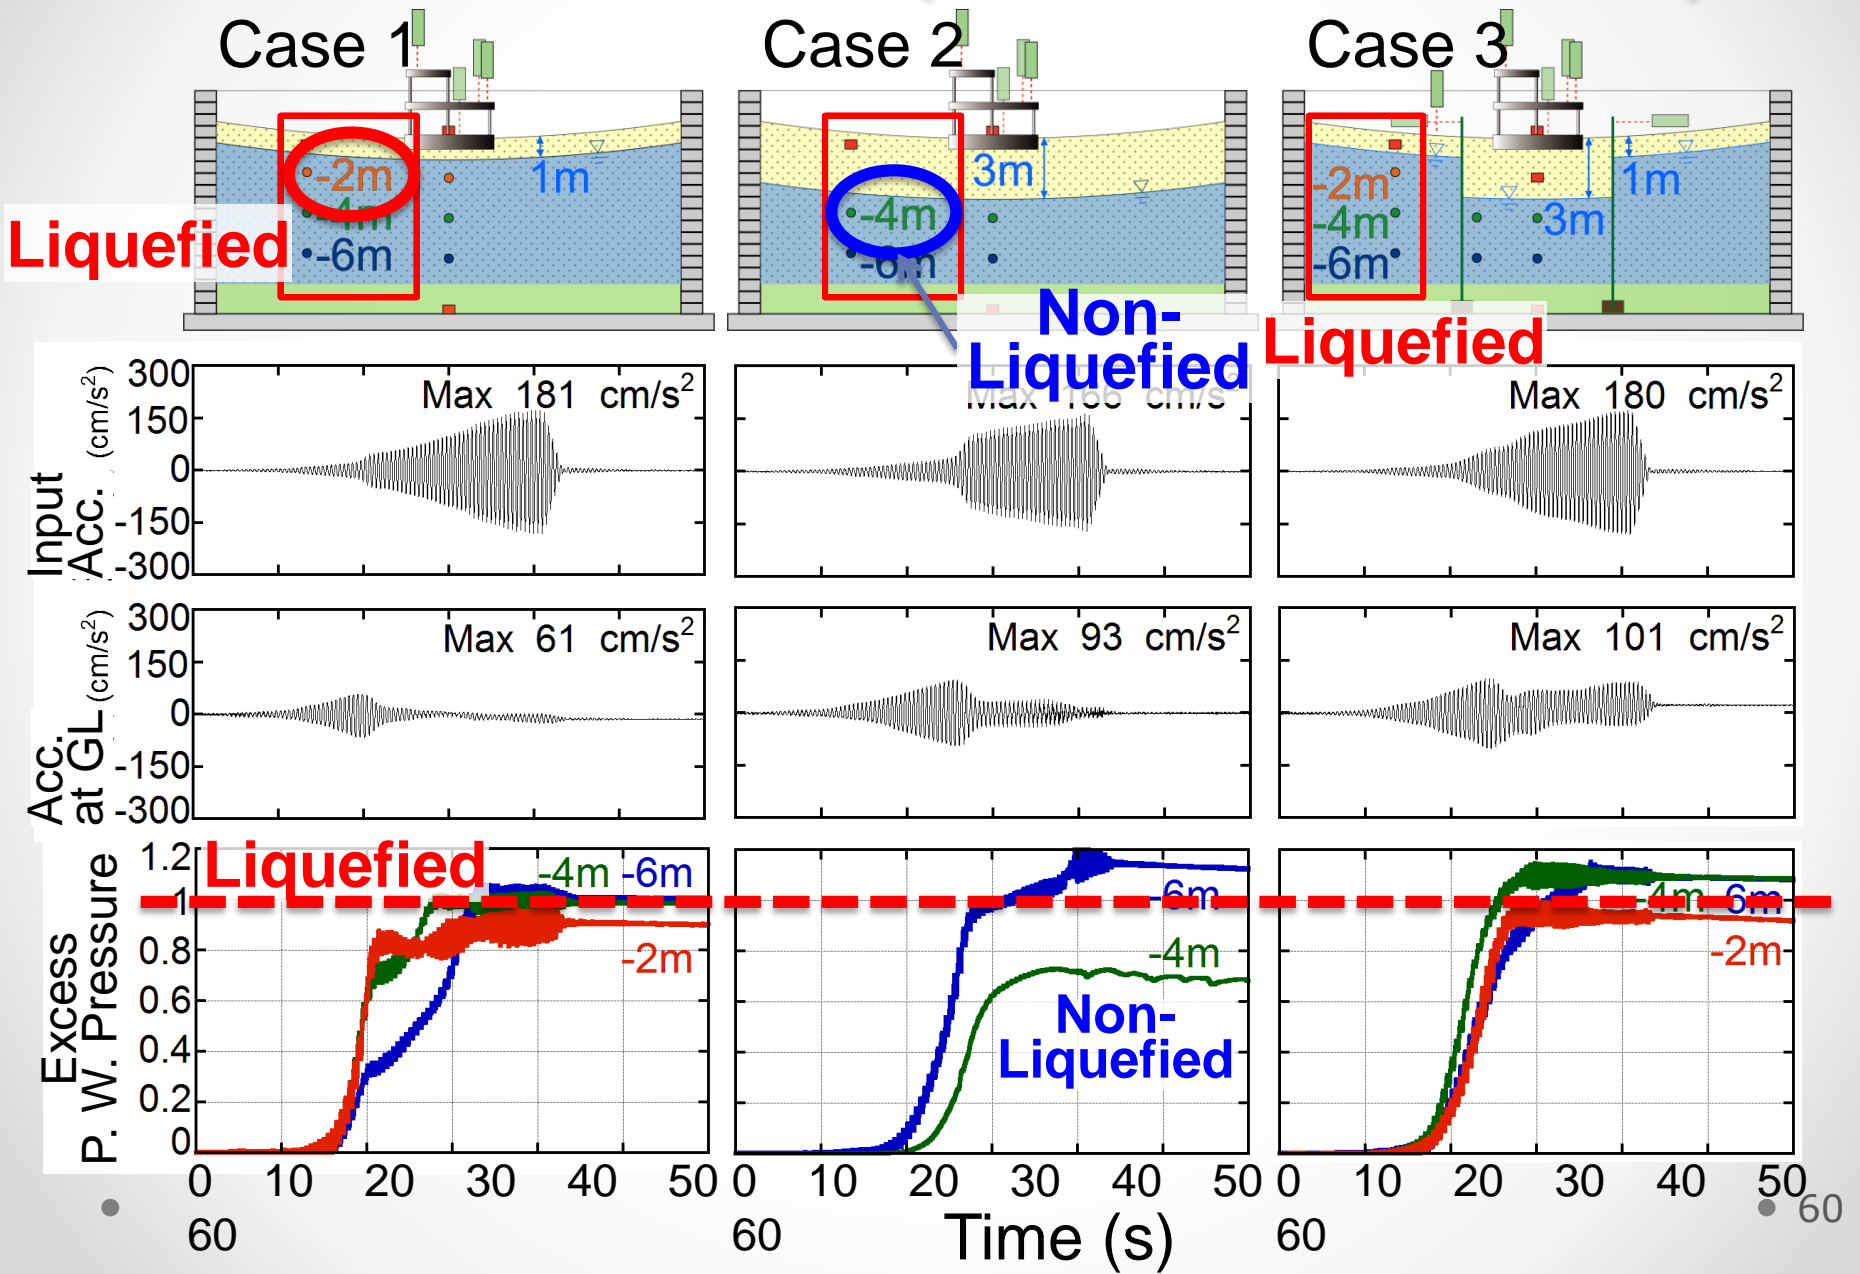
Test Results (Excess PWP)

- The objective is to evaluate the effectiveness of dewatering against liquefaction during an earthquake in the target site.
- The ground motion that was experienced in this area during Tohoku earthquake was applied.
